Drone Roof Inspection Report Sample

Document Type: Inspection Report	Distribution Status: External	Document Number: ARI-20260127-001
-------------------------------------	----------------------------------	--------------------------------------

Site Address: 123 Melbourne Street, Melbourne, VIC 1234 (Confidentiality)

Inspection by: Apex Roof Inspections – CASA Compliant operation

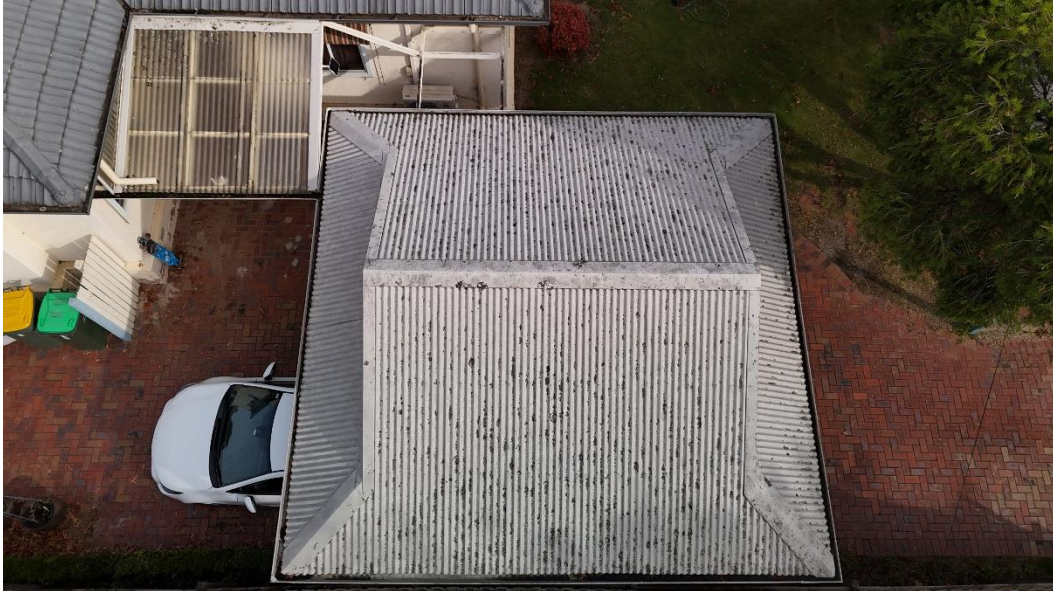
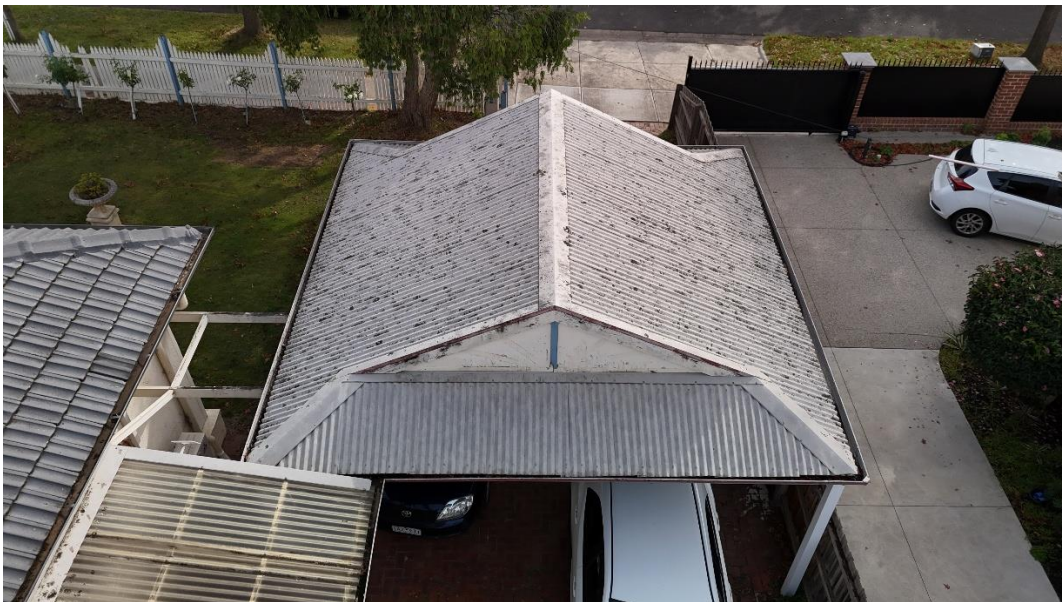
- Algae Formation (*Ref: Appendix A, A2 for further details*)

- Algae coverage across ~75% of roof plane

Severity: 🟡 Repair Recommended

- **Algae Formation** – May retain moisture on roof surfaces, potentially accelerating surface deterioration and increasing maintenance requirements.

Figure 3 – R01 annotated figure evidence 1

Figure 4 - R01 annotated figure evidence 2

- Schedule professional roof cleaning and treatment within 6 months

Estimated repair cost: \$400 - \$900 (*Algae and Lichen treatment for whole roof*)

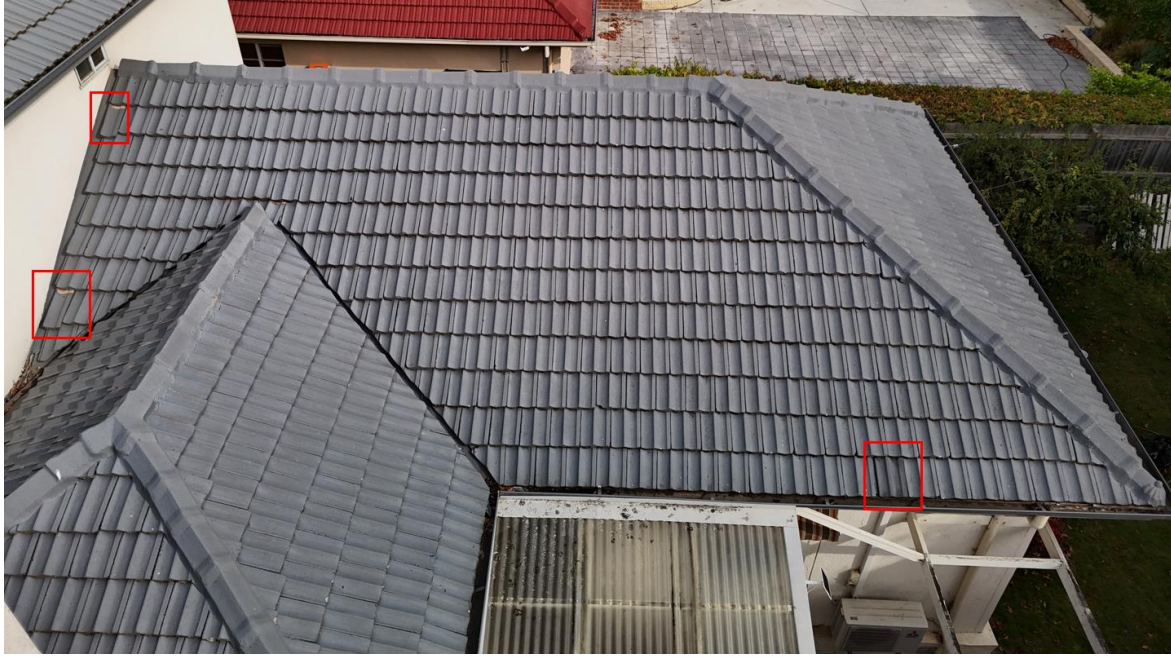
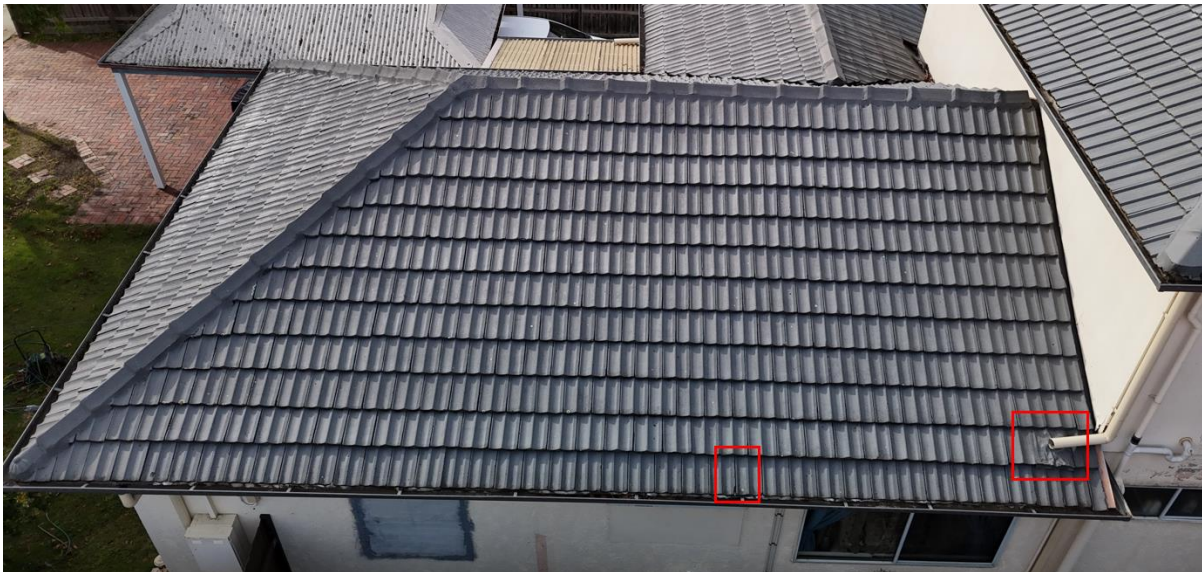
- Cracked Roof Tiles (*Ref: Appendix A, A1 for further details*)
- Slipped Roof Tiles (*Ref: Appendix A, A1 for further details*)
- Algae Formation (*Ref: Appendix A, A2 for further details*)
- Degraded Roof Tiles (*Ref: Appendix A, A3 for further details*)

- Approximately 1 cracked tile
- Approximately 3 slipped tiles
- Algae coverage across ~5% of roof plane
- Approximately 2 degraded tiles by water drain

Severity: 🟡 Repair Recommended

- **Cracked Tiles** – Increase water ingress during rainfall, increasing the risk of underlying material deterioration over time.
- **Slipped Tiles** – Gaps in the roof covering may form, increasing the risk of water ingress and further tile displacement.
- **Algae Formation** – Retain moisture on roof surfaces, potentially accelerating surface deterioration and increasing maintenance requirements.
- **Degraded Tiles** – May reduce weather resistance and increase water absorption, accelerating freeze-thaw damage and substrate deterioration.

Figure 5 – R02 annotated figure evidence 1

Figure 6 – R02 annotated figure evidence 2

- Replace identified damaged tiles within 3–6 months by a licensed roofing contractor
- Schedule professional roof cleaning and treatment within 6 months

Estimated repair cost: \$210 – \$390 (*based on approx. 6 tiles at Melbourne contractor rates — verify with licensed roofer*) + \$400 - \$900 (*Algae and Lichen treatment for whole roof*)

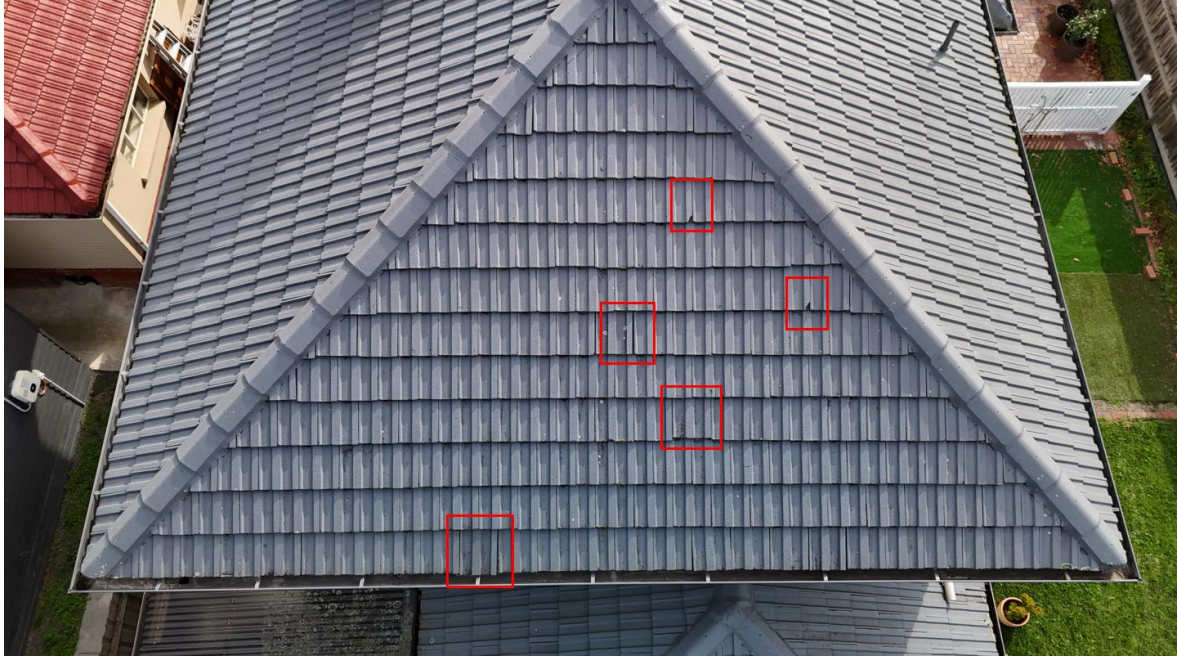
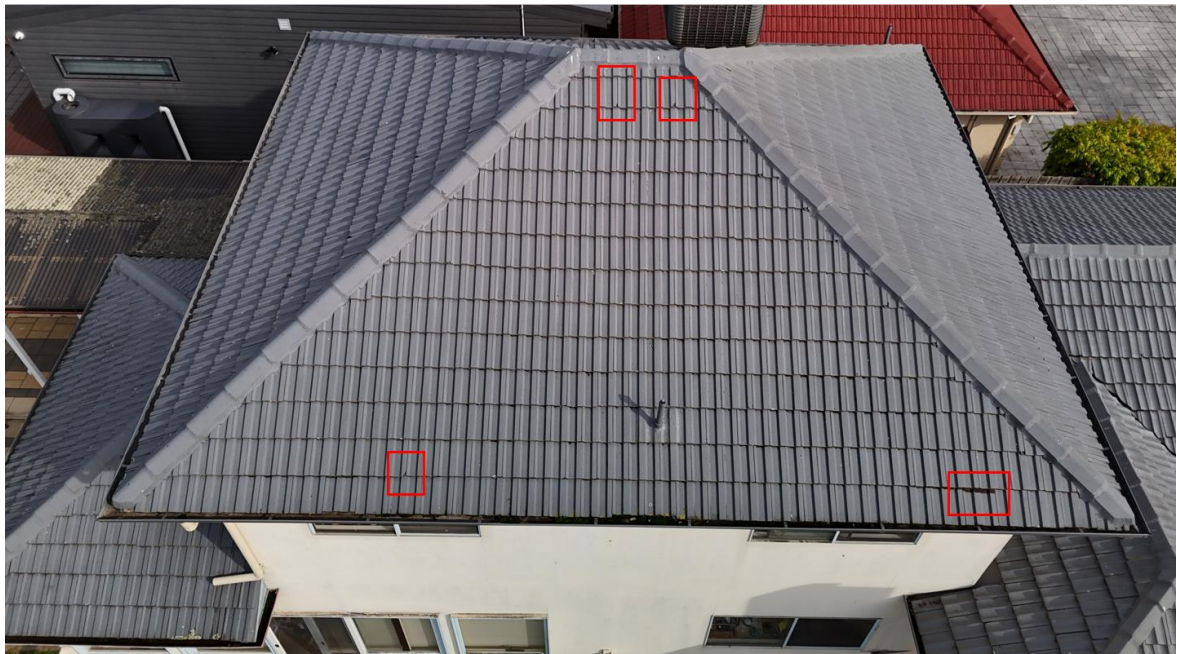
- Cracked Roof Tiles (*Ref: Appendix A, A1 for further details*)
- Slipped Roof Tiles (*Ref: Appendix A, A1 for further details*)
- Algae Formation (*Ref: Appendix A, A2 for further details*)

- Approximately 8 cracked tiles
- Approximately 3 slipped tiles
- Algae coverage across ~ 1% of roof plane

Severity: ● Monitor

- **Cracked Tiles** – May allow water ingress during rainfall, increasing the risk of underlying material deterioration over time.
- **Slipped Tiles** – Create exposed gaps in the roof covering, increasing the risk of water ingress and further tile displacement.
- **Algae Formation** – May retain moisture on roof surfaces, potentially accelerating surface deterioration and increasing maintenance requirements.

Figure 7 – R03 annotated figure evidence 1

Figure 8 – R03 annotated figure evidence 2

- Replace identified damaged tiles within 6-12 months by a licensed roofing contractor.
- Schedule professional roof cleaning and treatment within 12 months

Estimated repair cost: \$370 – \$700 (*based on approx. 11 tiles at Melbourne contractor rates — verify with licensed roofer*) + \$400 - \$900 (*Algae and Lichen treatment for whole roof*)

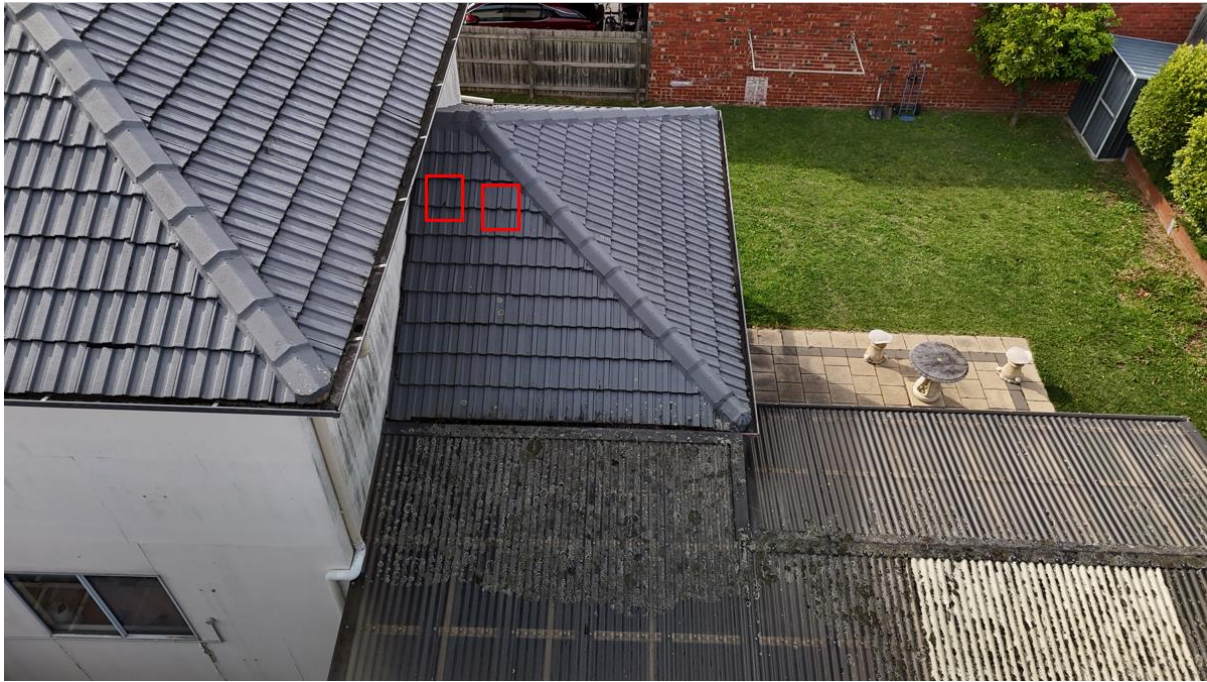
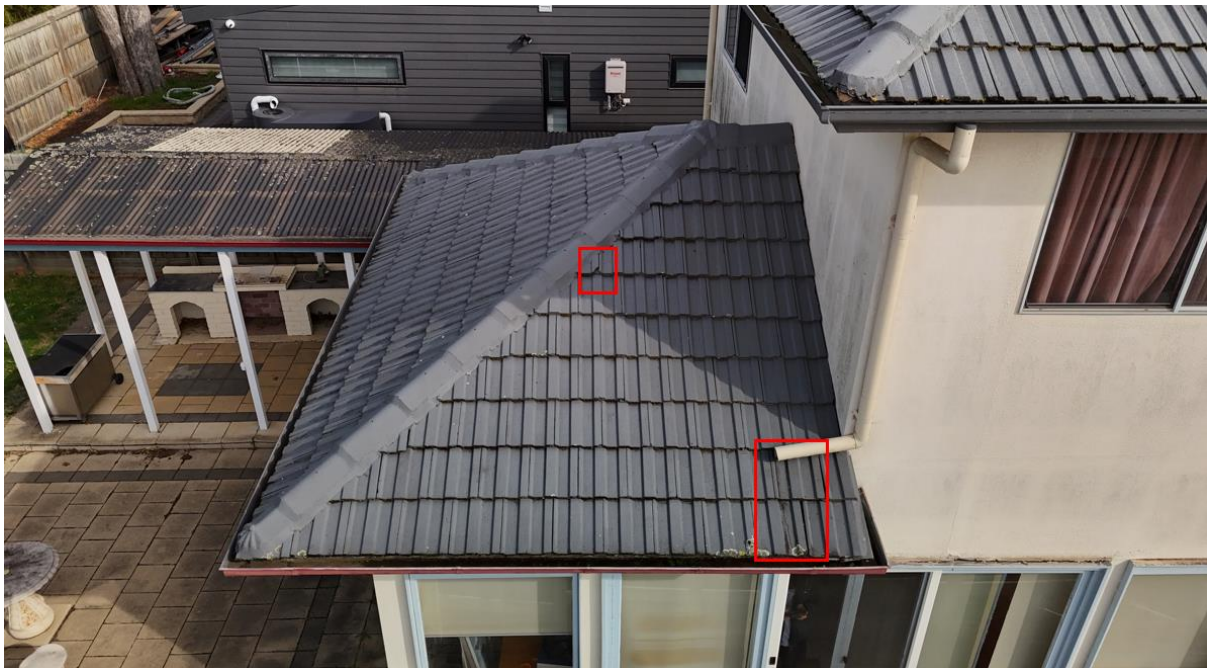
- Cracked Roof Tile (*Ref: Appendix A, A1 for further details*)
- Algae Formation (*Ref: Appendix A, A2 for further details*)

- Approximately 7 cracked tiles.
- Algae coverage across ~5% of roof plane

Severity: 🟡 Monitor

- **Cracked Tiles** – May allow water ingress during rainfall, increasing the risk of underlying material deterioration over time.
- **Algae Formation** – May retain moisture on roof surfaces, potentially accelerating surface deterioration and increasing maintenance requirements.

Figure 9 - R04 annotated figure evidence 1

Figure 10 - R04 annotated figure evidence 2

- Replace identified damaged tiles within 3–6 months by a licensed roofing contractor
- Schedule professional roof cleaning and treatment within 6 months

Estimated repair cost: \$315 – \$585 (*based on approx. 7 tiles at Melbourne contractor rates — verify with licensed roofer*) + \$400 - \$900 (*Algae and Lichen treatment for whole roof*)

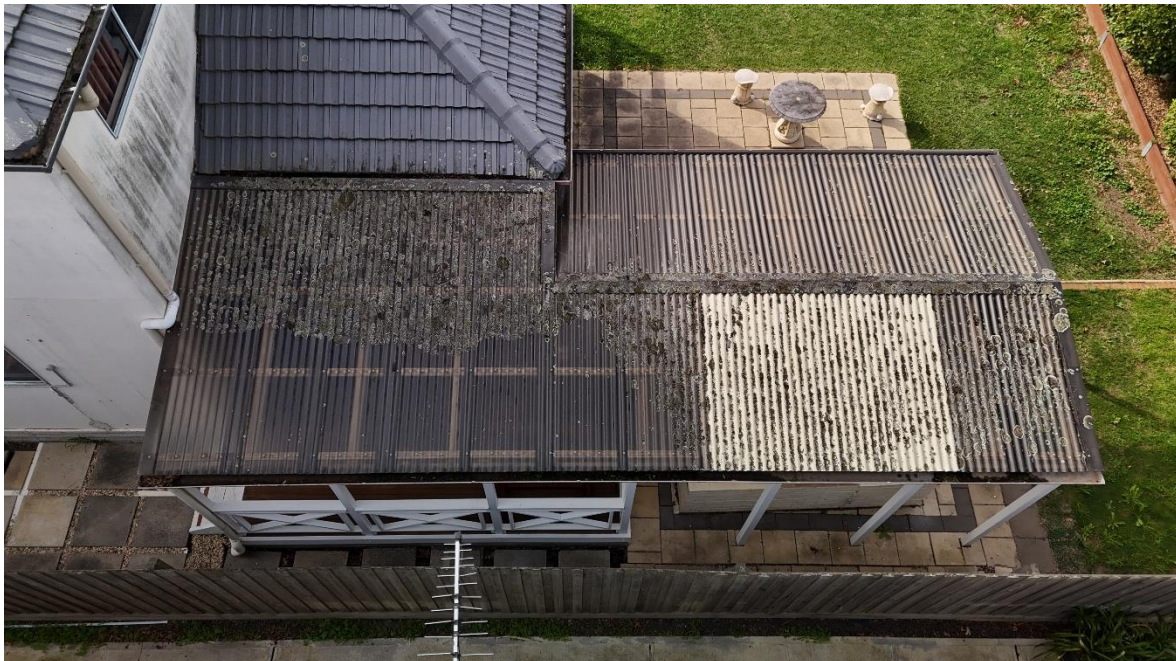
- Algae Formation (*Ref: Appendix A, A2 for further details*)

- Algae coverage across ~60% of roof plane

Severity: 🟡 Repair Recommended

- **Algae Formation** – May retain moisture on roof surfaces, potentially accelerating surface deterioration and increasing maintenance requirements.

Figure 11 - R05 annotated figure evidence 1

- Schedule professional roof cleaning and treatment within 6 months

Estimated repair cost: \$400 - \$900 (*Algae and Lichen treatment for whole roof*)

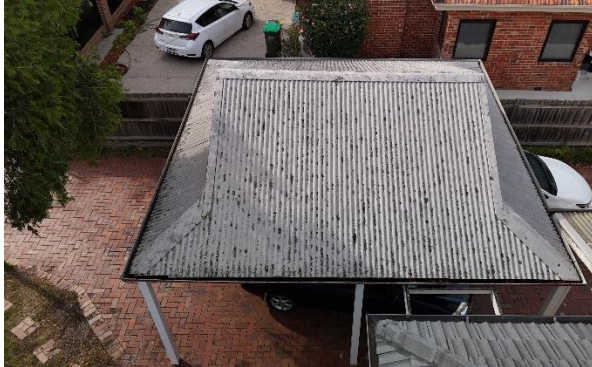
Figure 12 – R01 annotated image 1

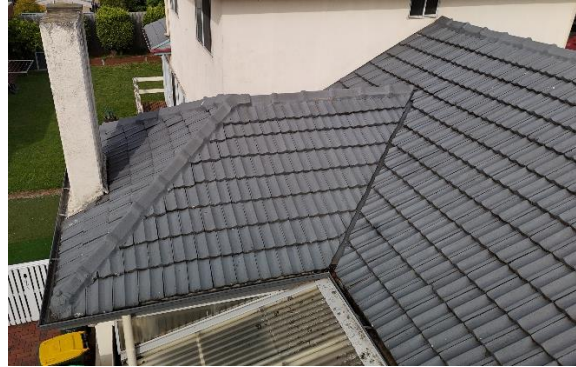
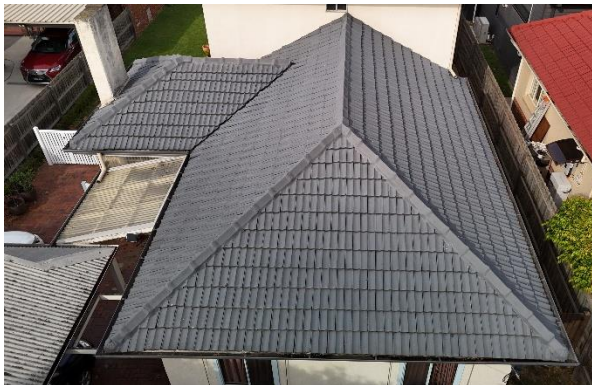
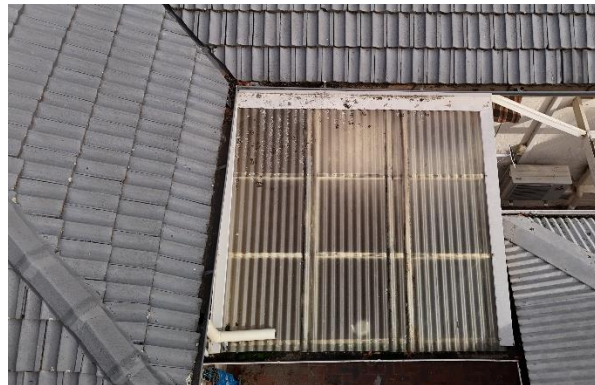
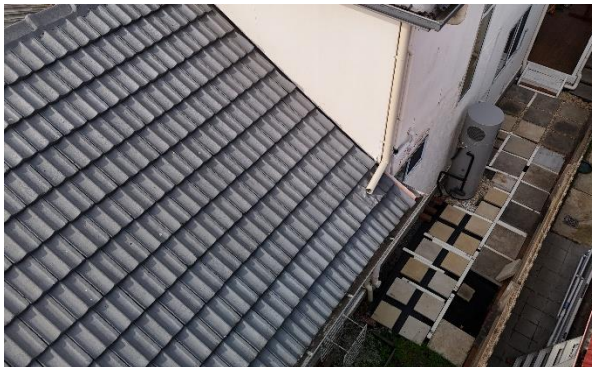
Figure 13 - R02 annotated image 1

Figure 14 - R02 annotated image 2

Figure 15 - R02 annotated image 3

Figure 16 - R02 annotated image 4

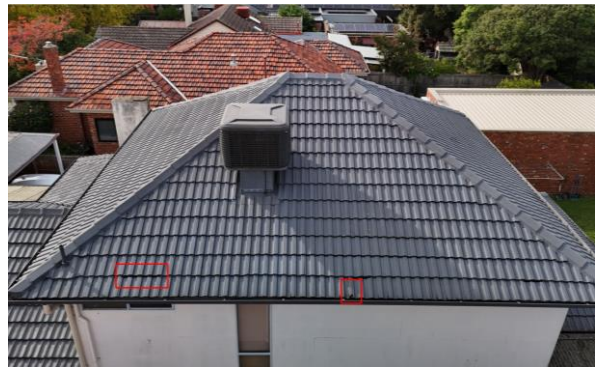
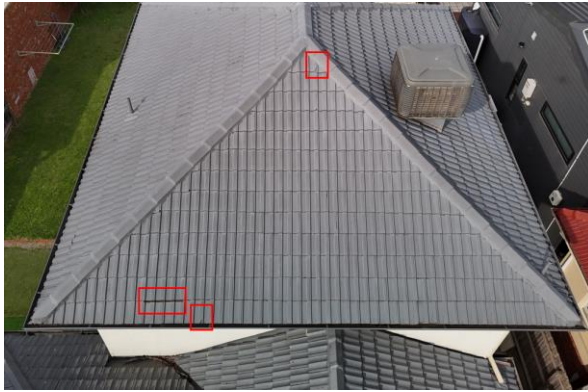
Figure 17 - R03 annotated image 1

Figure 18 - R03 annotated image 2

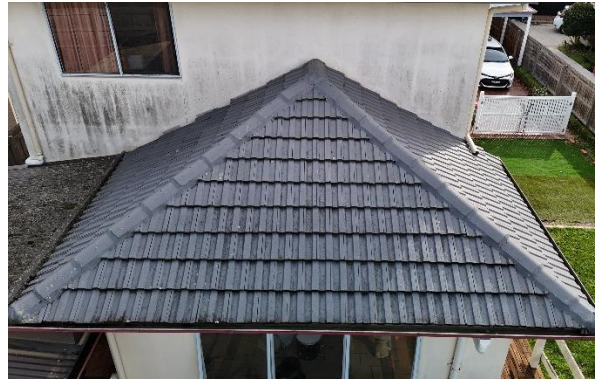
Figure 19 - R04 annotated image 2

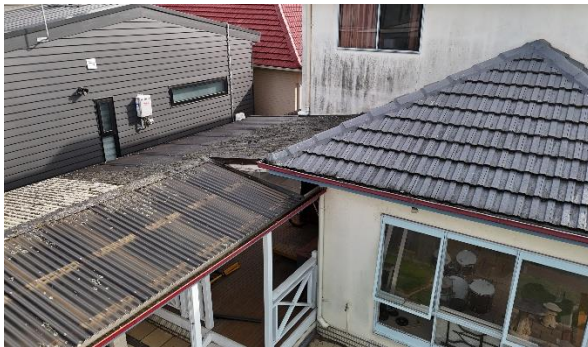
Figure 20 - R05 annotated image 1

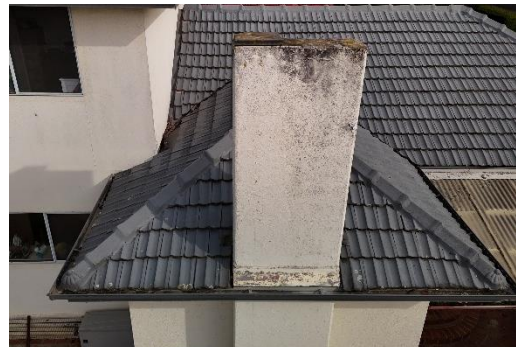
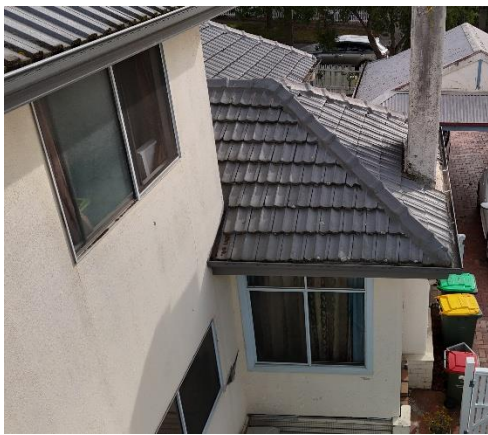
Both chimneys are structurally sound with intact pointing and functional chimney pots. Flashing around chimney bases shows no significant deterioration. Images of the Chimney can be found in Appendix B, figure 21 and figure 22.

Figure 21 - Chimney Image 1

Figure 22 - Chimney image 2
